REPORT OF COMPLIANCE EVALUATION INSPECTION
(CONSTRUCTION STORM WATER)

Westown Parkway and R22 Intersection Improvements

Waukee, Iowa 50263

OCTOBER 12 AND 14, 2016

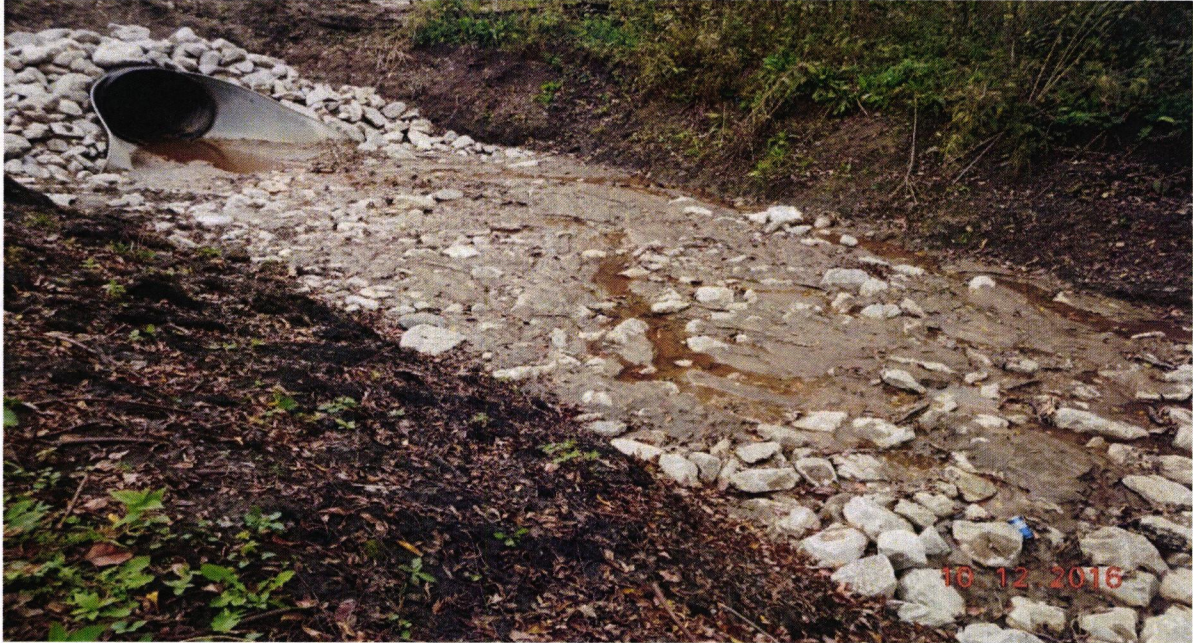
wooded area toward the stream. There was about six inch of sediment accumulating in this area (DSCN1817), evidence of sediment passing through the silt fence (DSCN1819), and sediment accumulating against the silt fence dams (DSCN1820) were very visible. I was able to track the sediment (DSCN1805-1808, 1810-812, and 1815-1816) to the tributary as shown in DSCN1808 below.

DSCN1816, Outlet #10, significant sediment traveling downstream to the tributary.

Based on my observations at this location I issued NOPV#1 because The City of Waukee

failed to prevent sediment from site from entering the Tributary

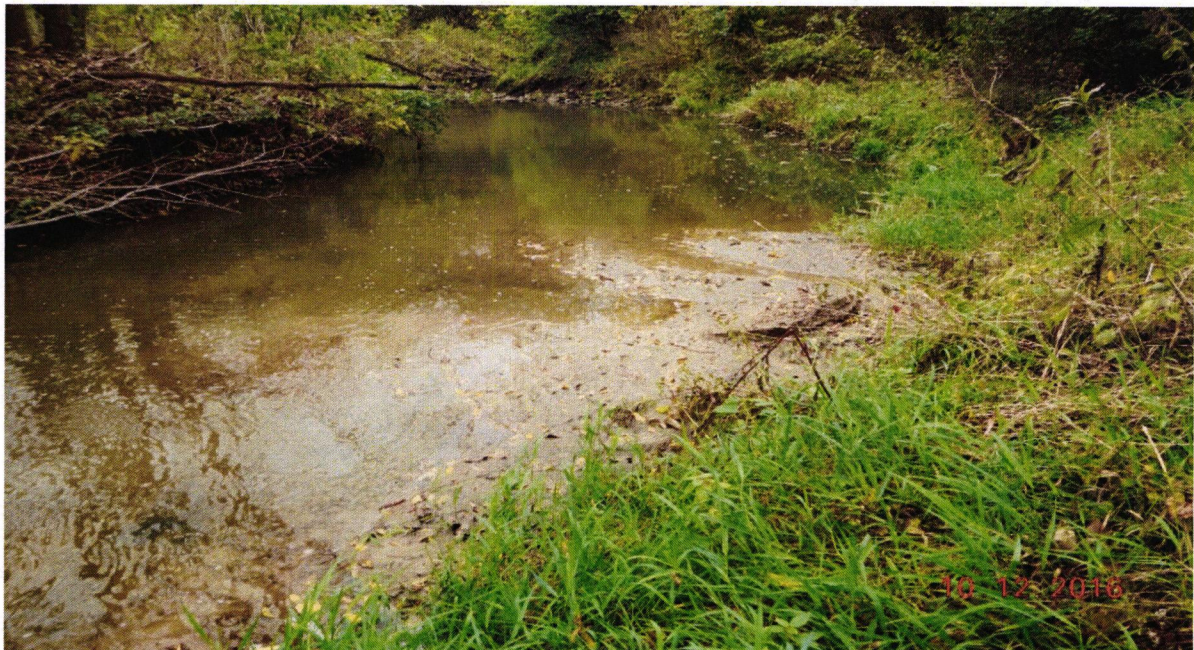
8. I also observed evidence of sediment from the south ditch into the Glynn Village project site. Sediment passed through at least five stages of silt fence ditch dams into the tributary. Photos DSCN1809, 1813-1814, and 1817-1818 show sediment accumulating in the sloped

DSCN1808, sediment deposit in the tributary to Sugar Creek from outlet #10.

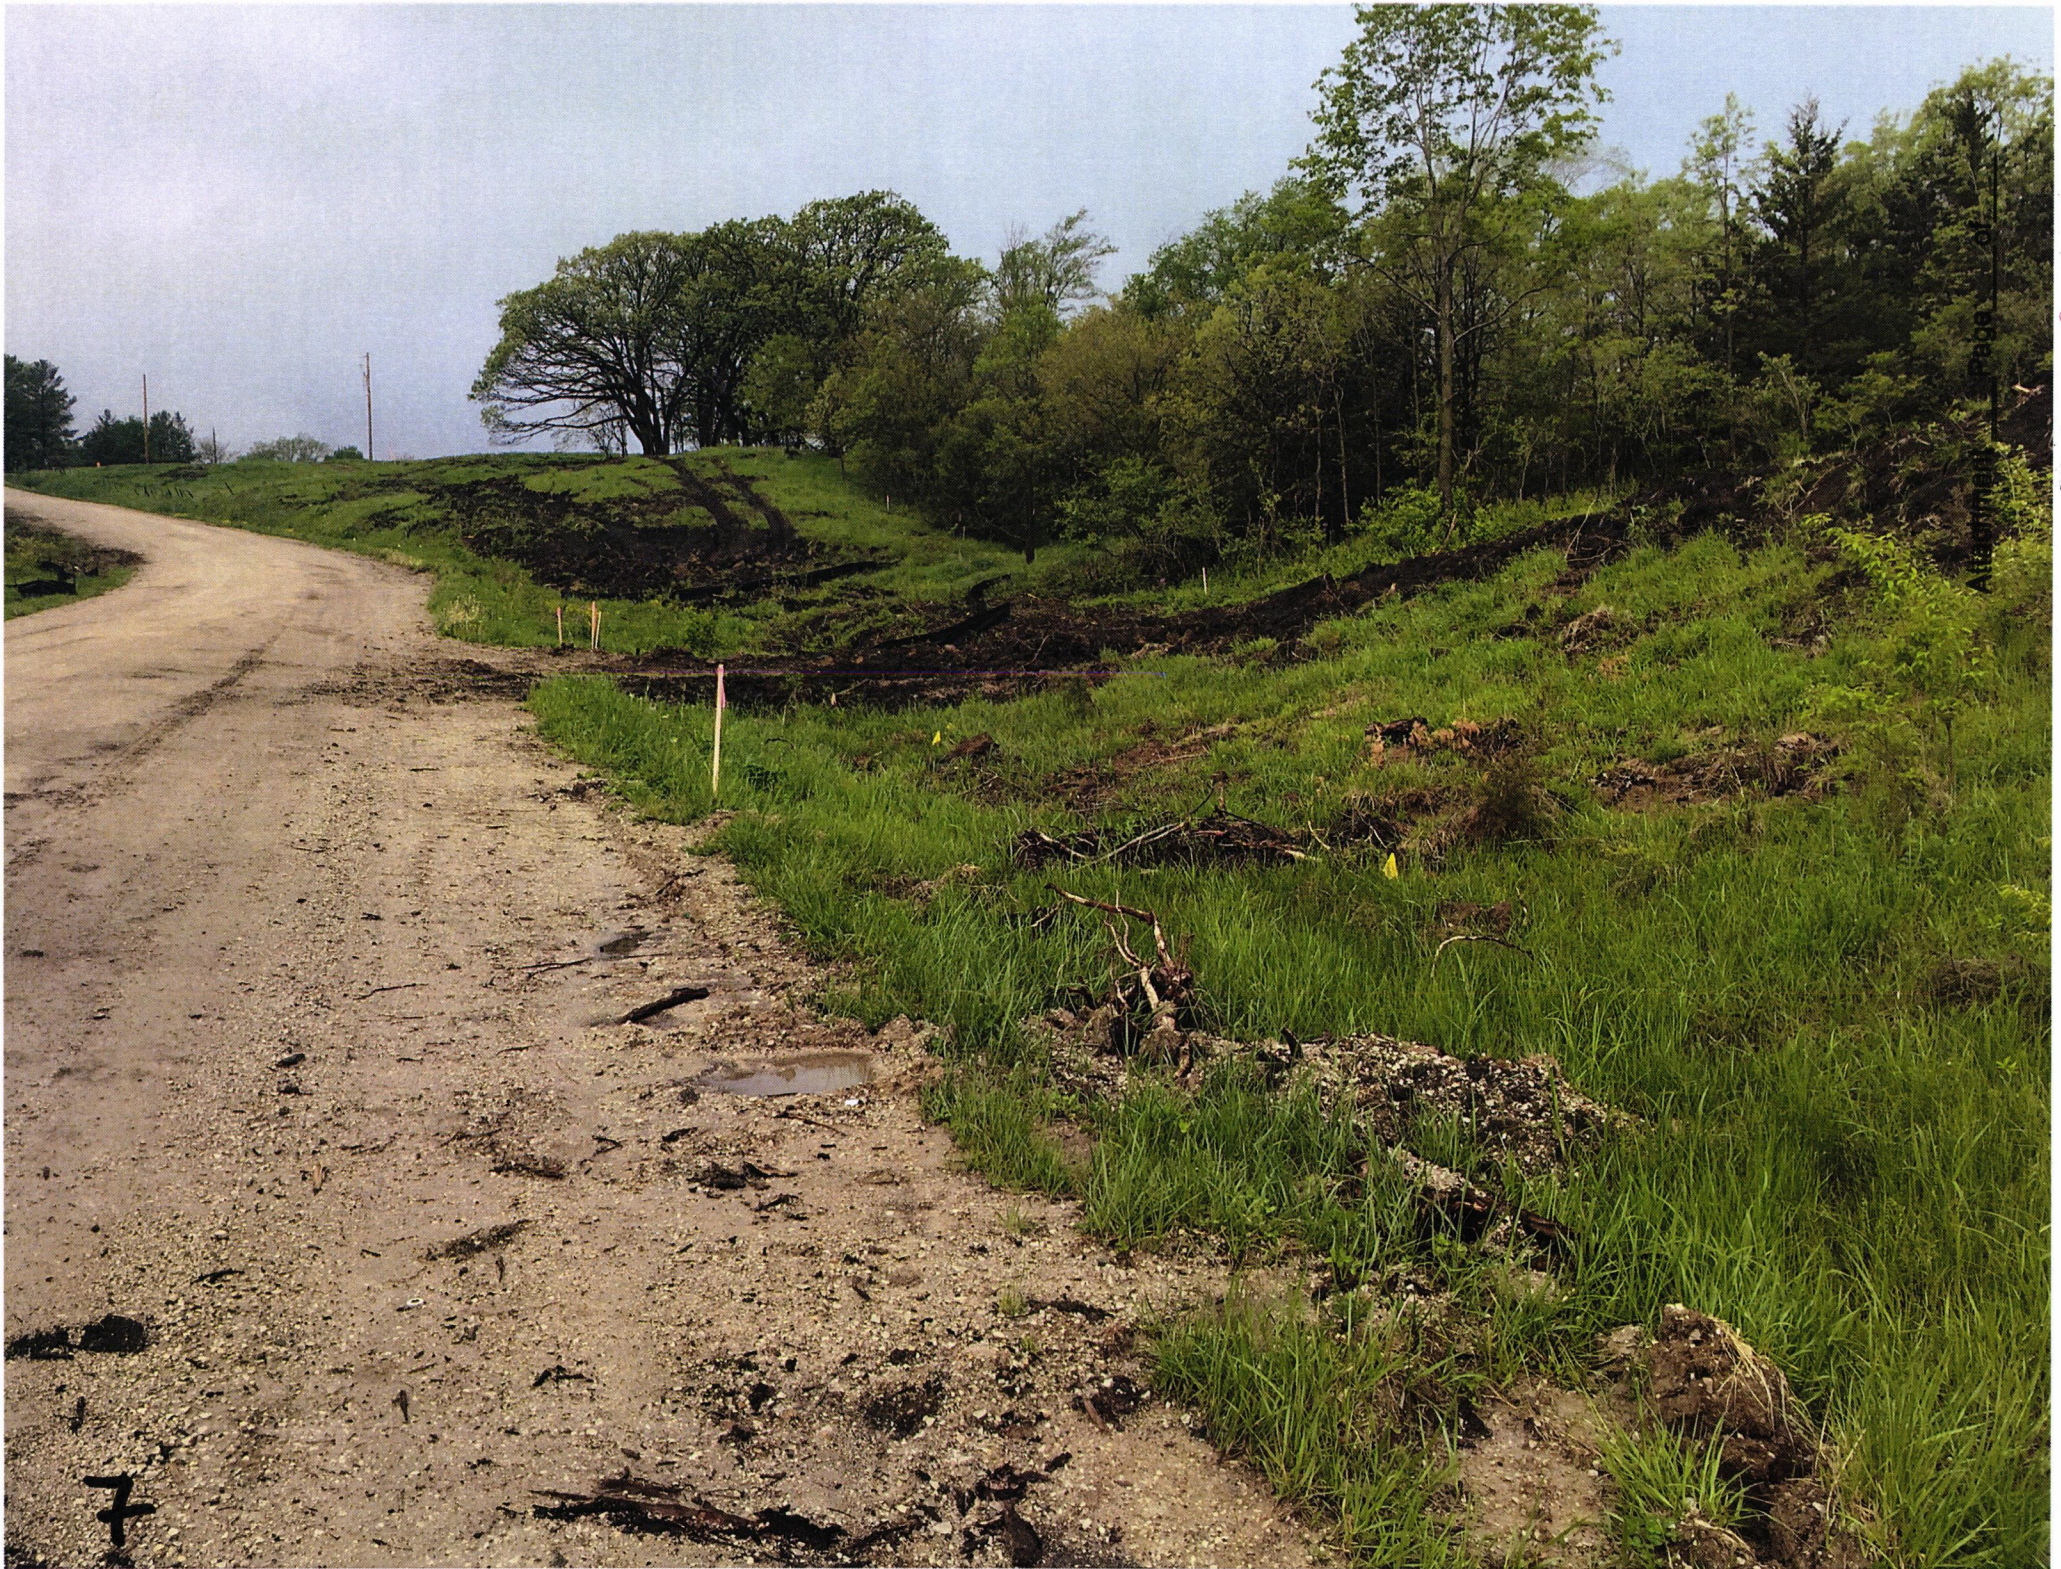
- Exhibit B-7 is looking west at the north side controls previously installed.
- Stripping activity noted to have begun on May 17, 2016 weekly inspection report. See Exhibit B-8, B-9 & B-10 attached.

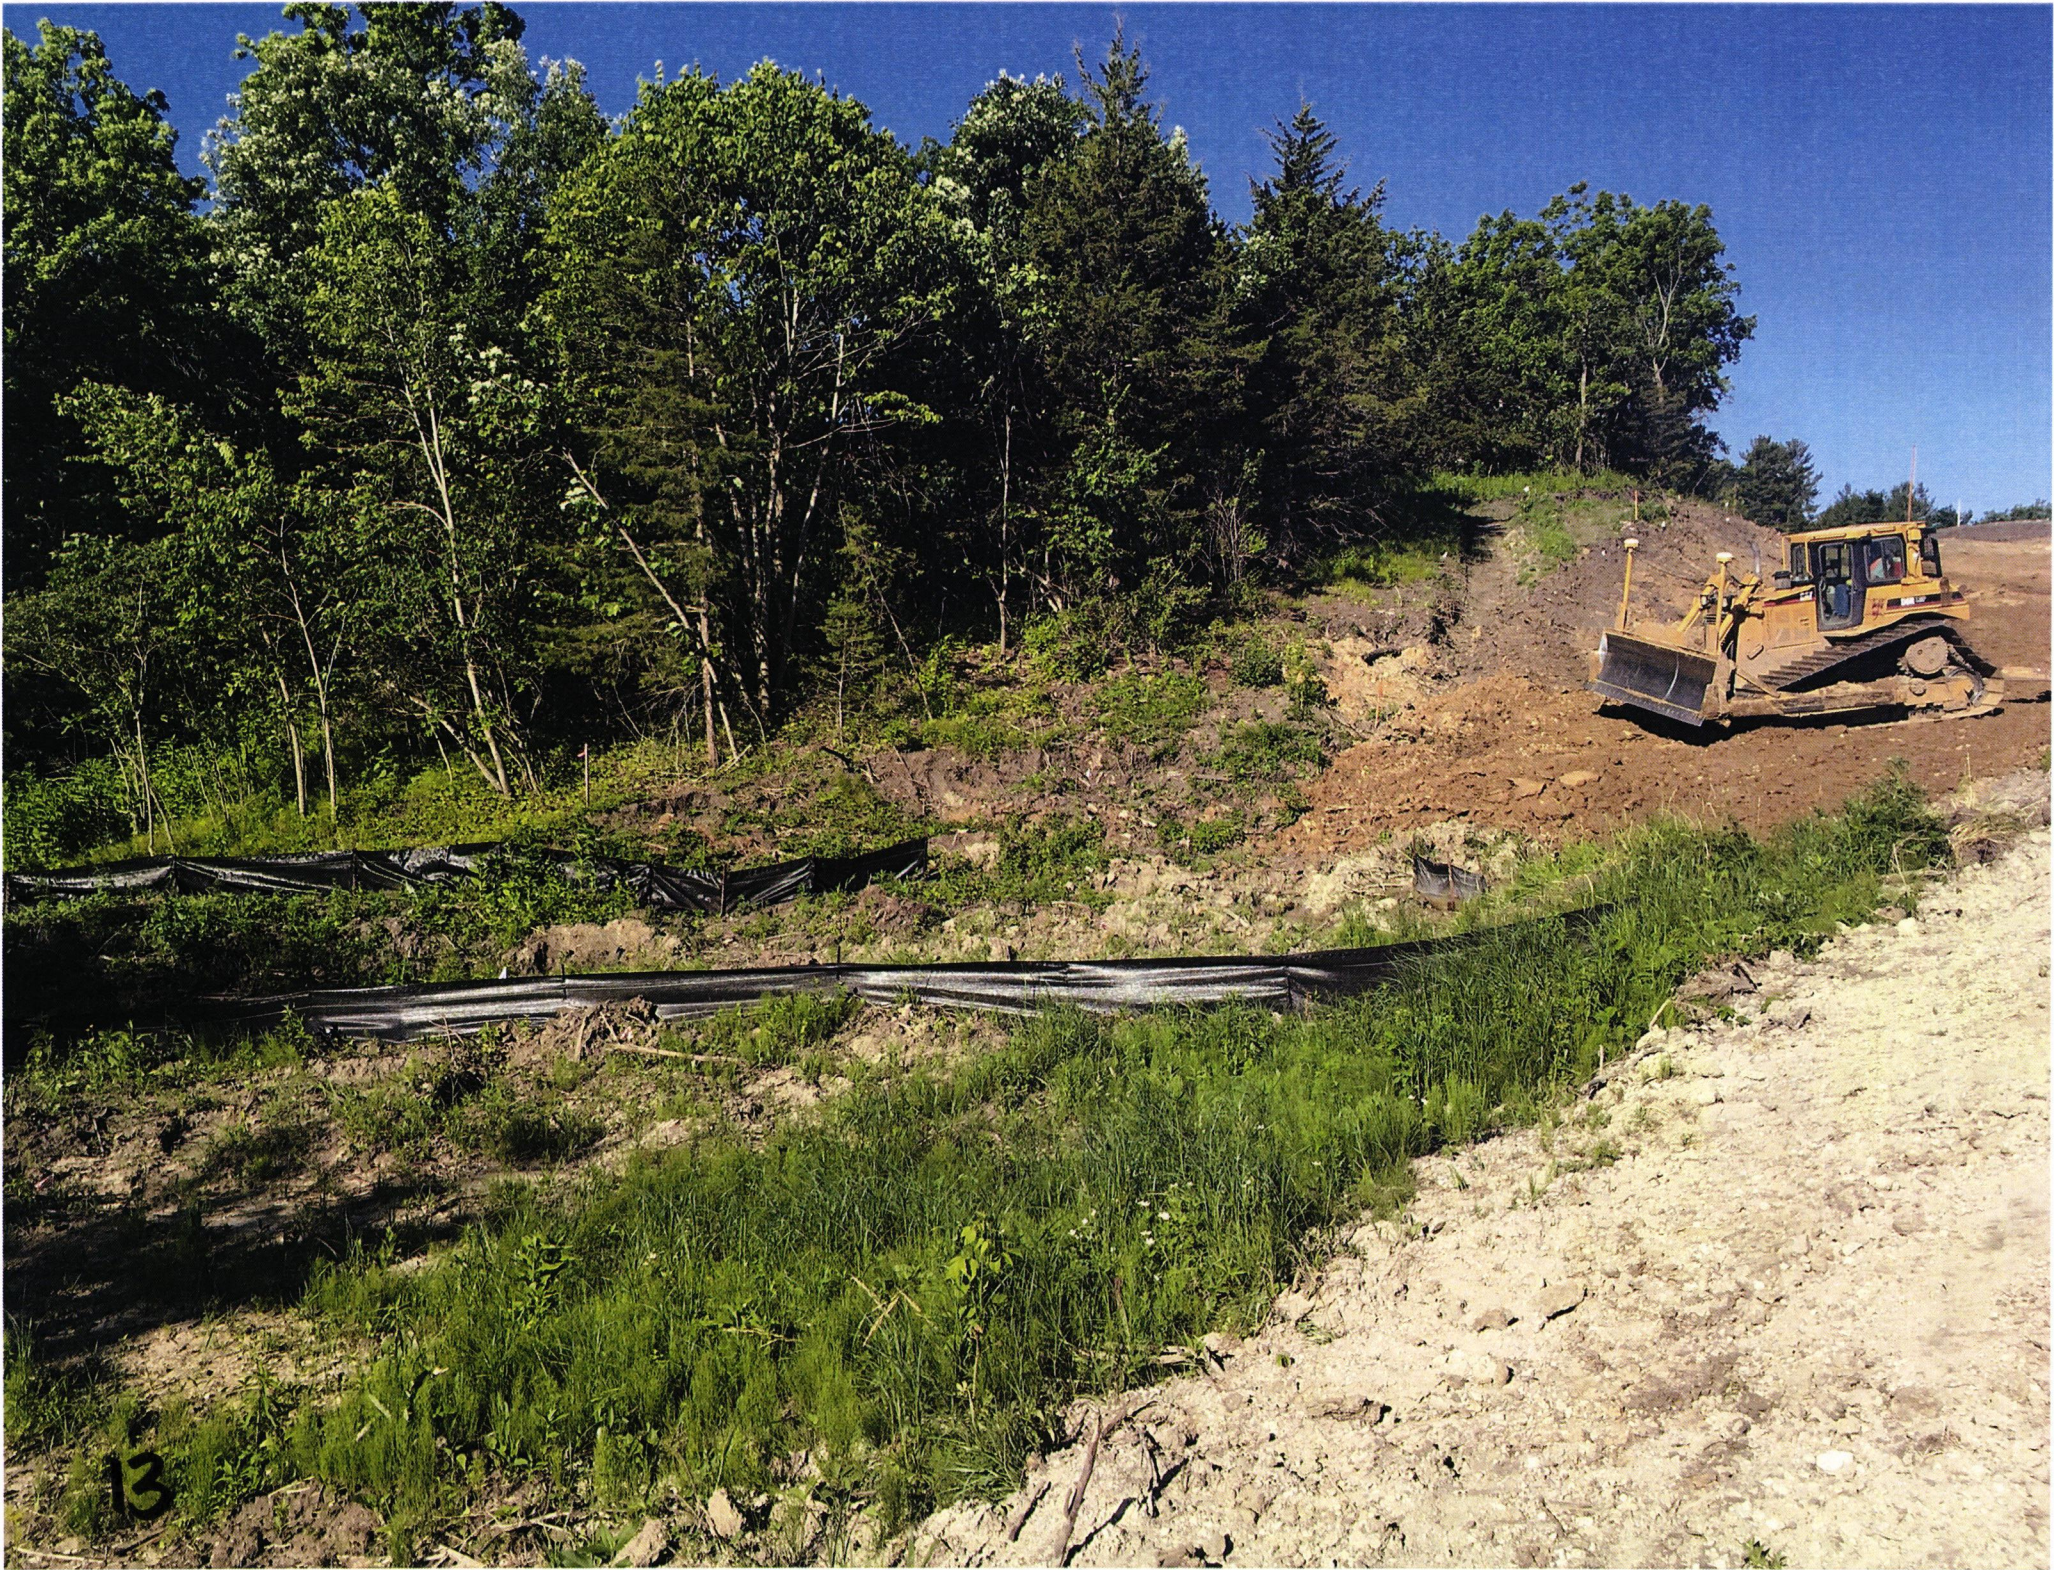
13

- Earthwork continued for many weeks; see Exhibit B-11 & B-12 to document site on May 31, 2016 and Exhibit B-13 & B-14 from June 7, 2016. Additional control near final outfall for added grading noted on report from June 7.

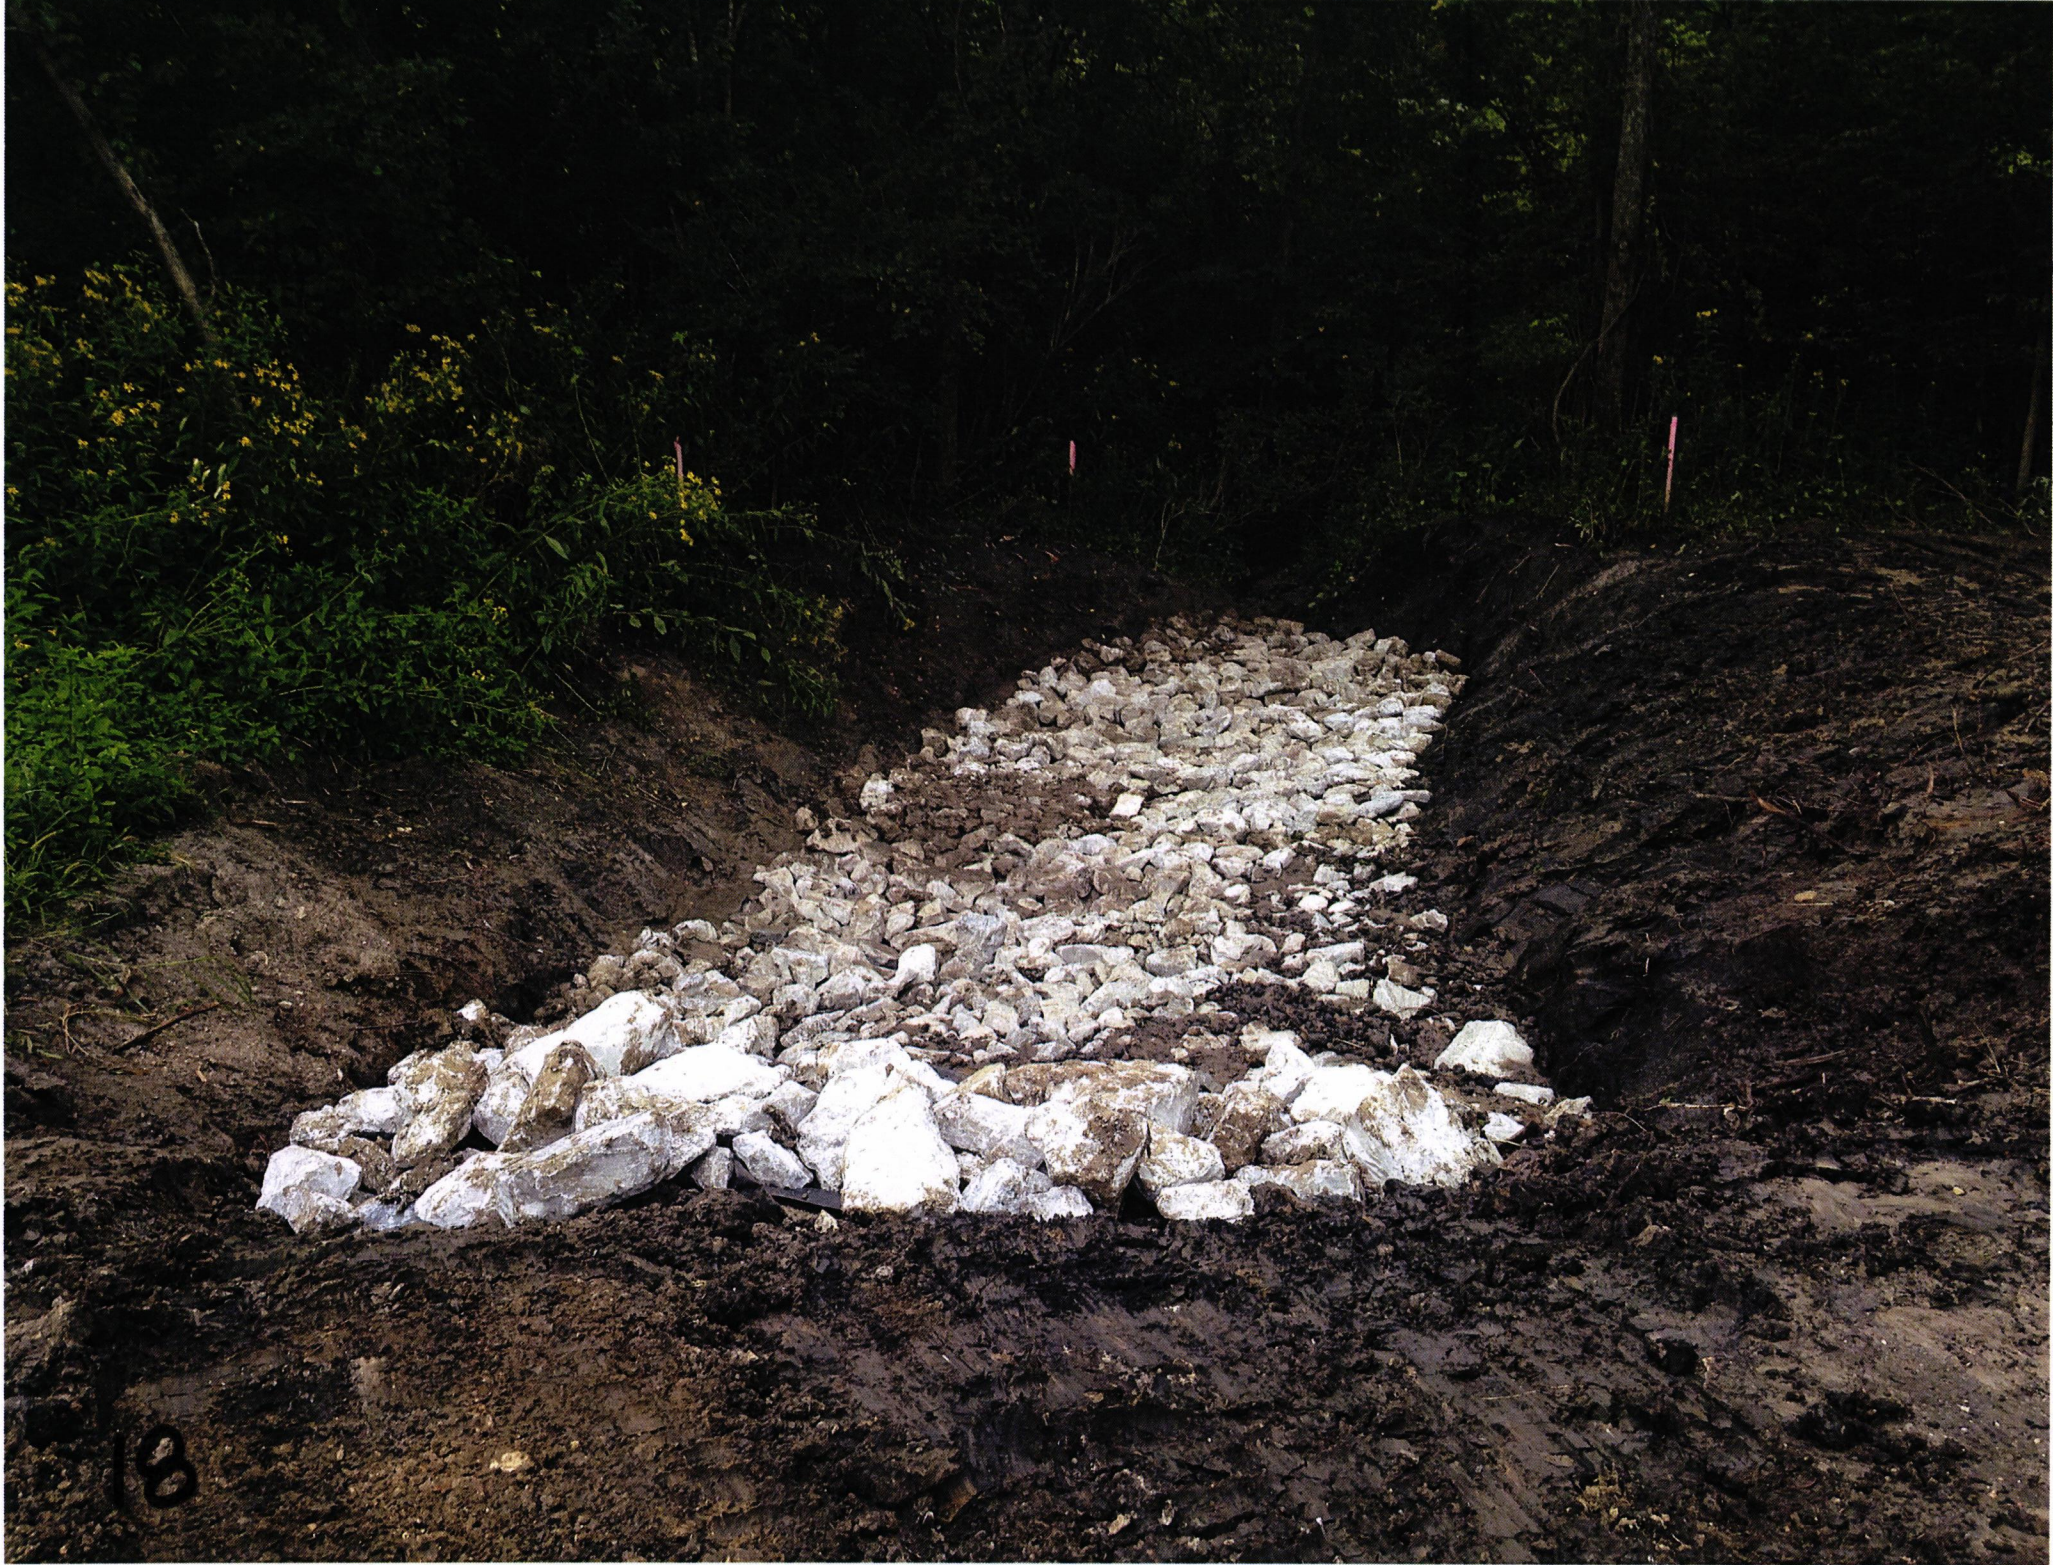
18

- The 8/16/16 weekly report documented that rip rap is in place. Request for cleaning of ditch checks noted and more requested to be installed. Note that at this time no sediment was leaving the site. Intakes are noted to be covered with steel plates. Exhibit B-18 shows the rip rap

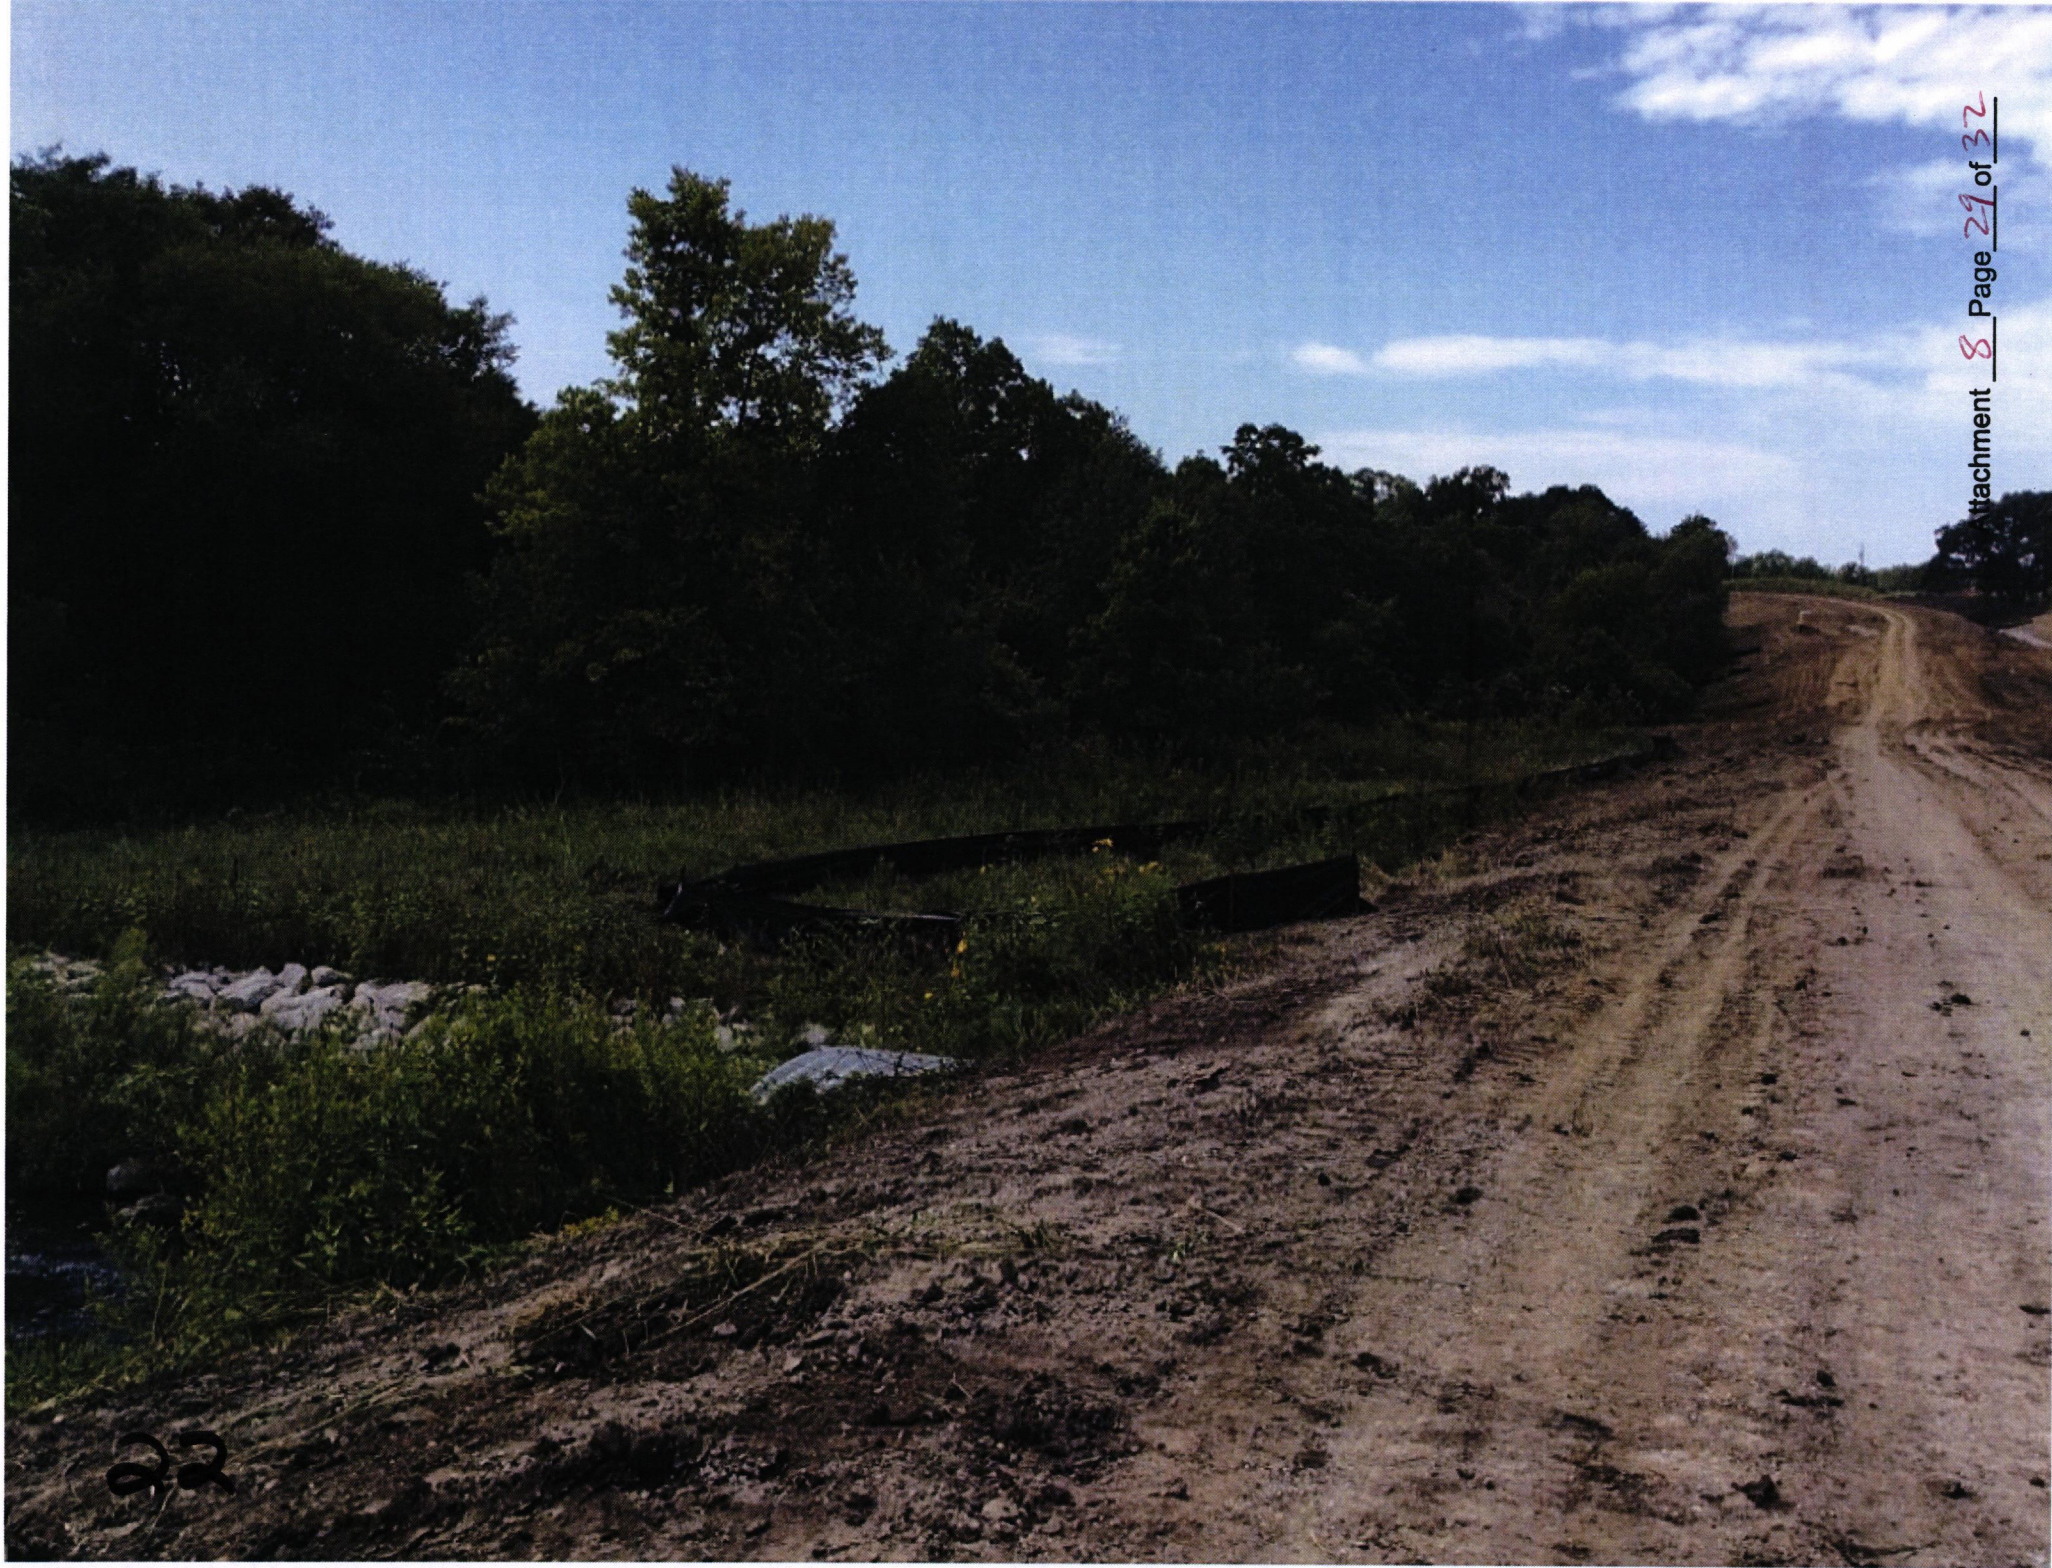
- See Exhibit B-22 for conditions observed 8/29/16. This picture was taken from the Glynn Village site looking west and it shows controls in place in the distance as shown on Exhibit A.
